NSPS 0000a Annual Report

Oxy Permian Resources New Mexico Delaware Basin

Initial Reporting Period: 9/19/2015 – 8/2/2017

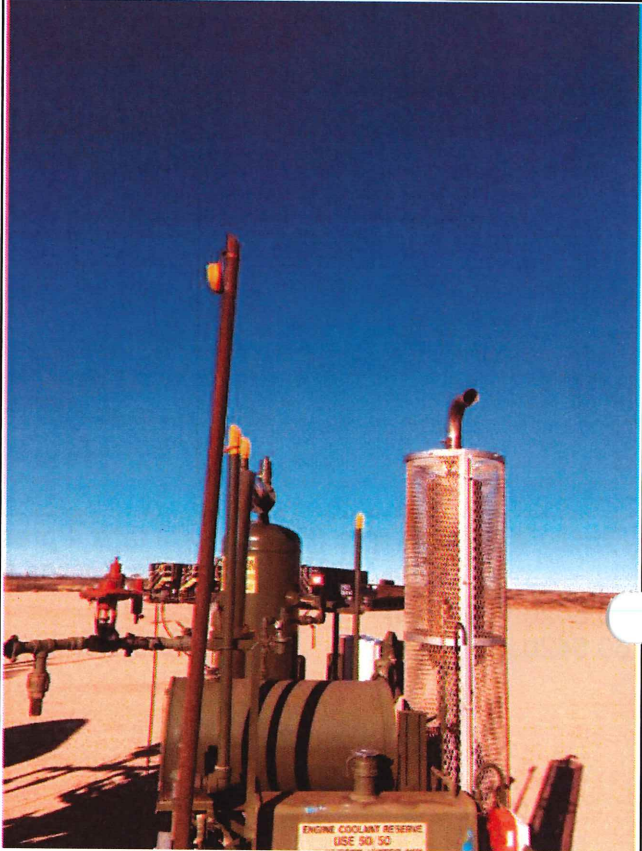
Type of Leaking Component?	Describe Leaking Component Location	Take iPhone photograph of leaking component and identify location.
Other (please describe) 60.5420a(b)(7)(vii) 60.5420a(b)(7)(viii)	Compressor MP-1079 left side of scrubber vent line compressor is off 60.5420a(c)(15)(ii)(I)(8)

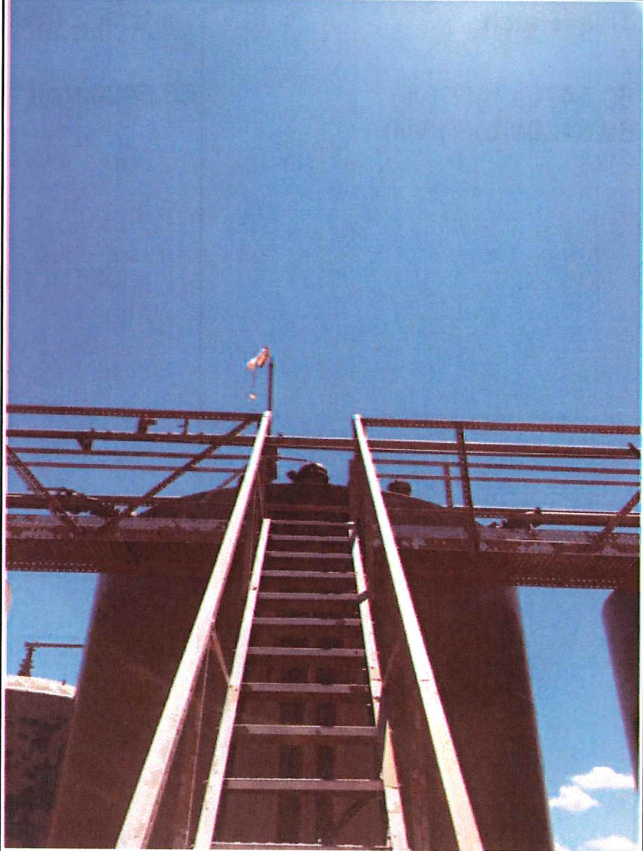
Type of Leaking Component?	Describe Leaking Component Location	Take iPhone photograph of leaking component and identify location.
Thief Hatch 60.5420a(b)(7)(vii) 60.5420a(b)(7)(viii)	Oil tank 2 thief hatch 60.5420a(c)(15)(ii)(I)(8)

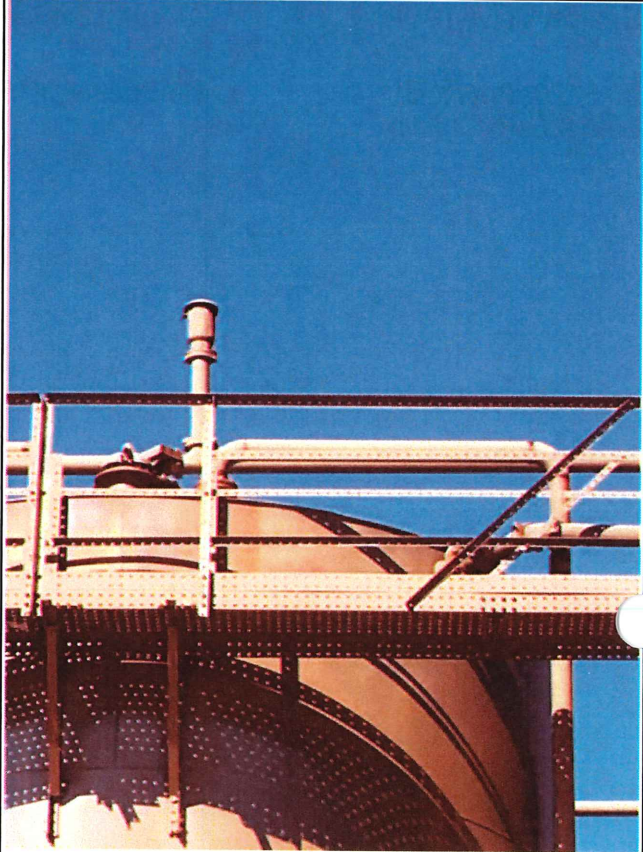
Type of Leaking Component?	Describe Leaking Component Location	Take iPhone photograph of leaking component and identify location.
Other (please describe) 60.5420a(b)(7)(vii) 60.5420a(b)(7)(viii)	Oil tank 3 tank pressure relief valve 60.5420a(c)(15)(ii)(l)(8)

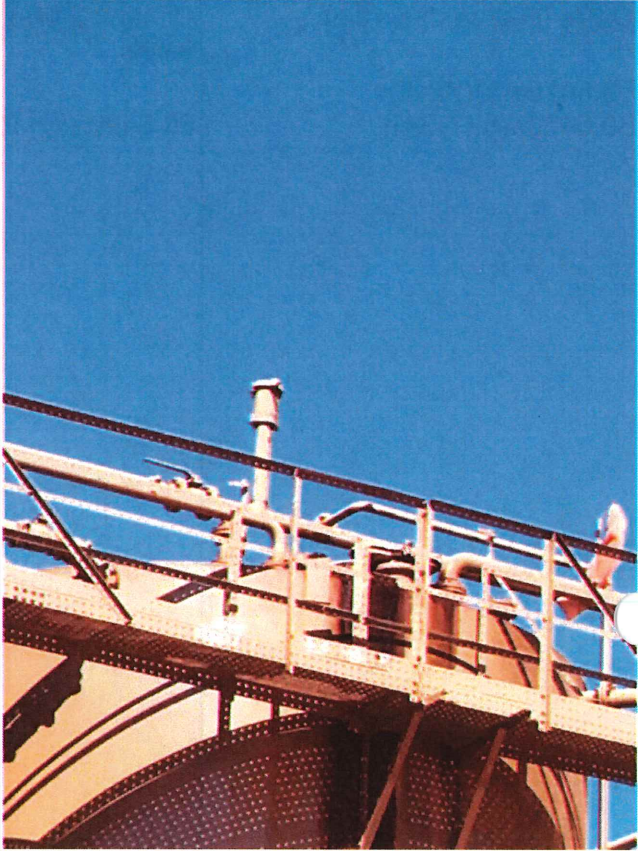
Type of Leaking Component?	Describe Leaking Component Location	Take iPhone photograph of leaking component and identify location.
Enardo Valve (PVRV) 60.5420a(b)(7)(vii) 60.5420a(b)(7)(viii)	Oil tank 2 enardo 60.5420a(c)(15)(ii)(l)(8)

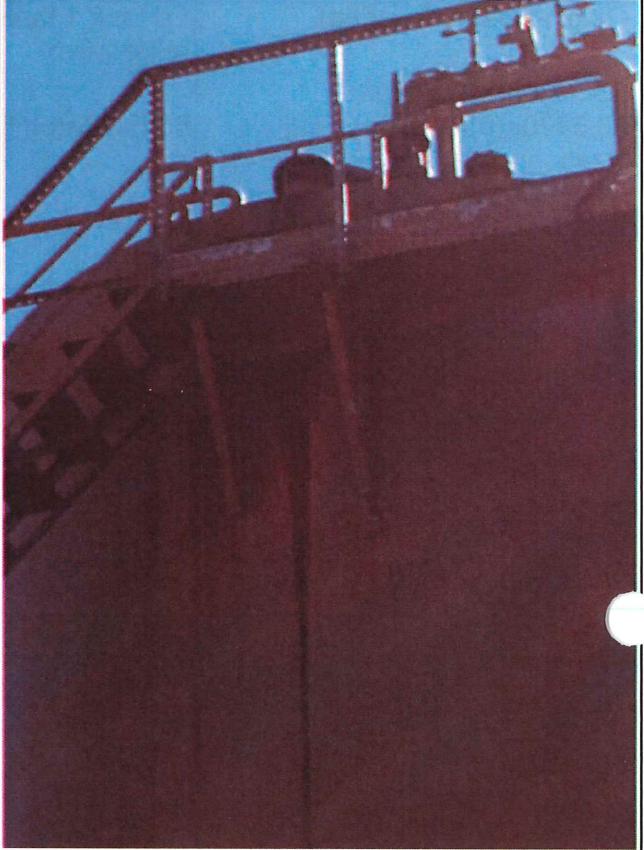
Type of Leaking Component?	Describe Leaking Component Location	Take iPhone photograph of leaking component and identify location.
Other (please describe) 60.5420a(b)(7)(vii) 60.5420a(b)(7)(viii)	Oil tank 5 tank pressure relief valve 60.5420a(c)(15)(ii)(I)(8)

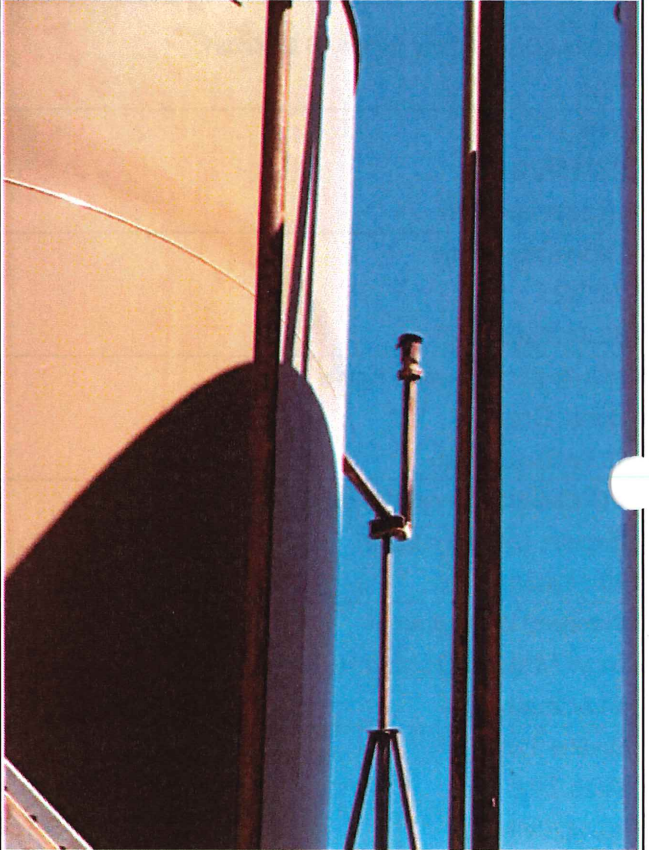
Type of Leaking Component?	Describe Leaking Component Location	Take iPhone photograph of leaking component and identify location.
Enardo Valve (PVRV) 60.5420a(b)(7)(vii) 60.5420a(b)(7)(viii)	Oil tank 1 common tank vent line enardo 60.5420a(c)(15)(ii)(l)(8)

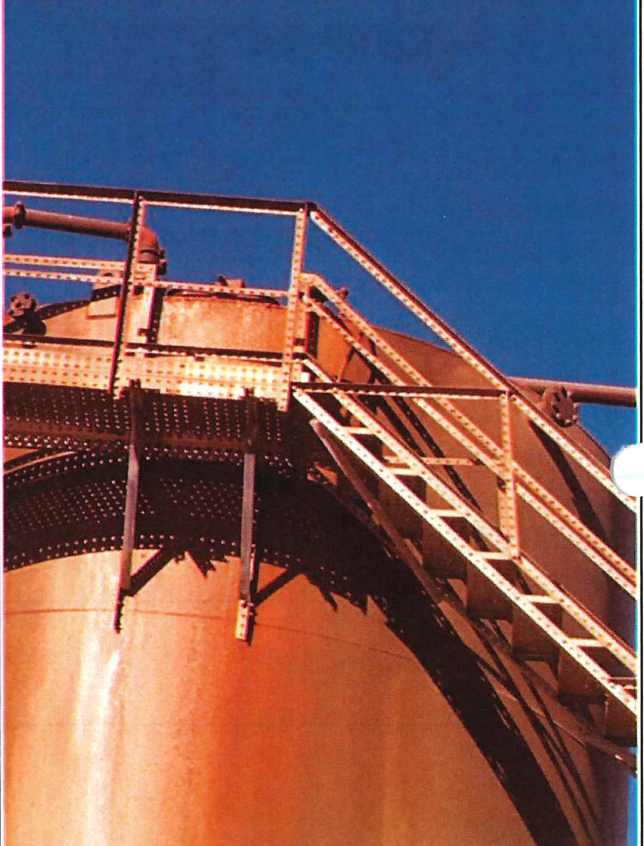
Type of Leaking Component?	Describe Leaking Component Location	Take iPhone photograph of leaking component and identify location.
Thief Hatch 60.5420a(b)(7)(vii) 60.5420a(b)(7)(viii)	Oil tank S/N 37286 tank #73006408-1 thief hatch 60.5420a(c)(15)(ii)(l)(8)

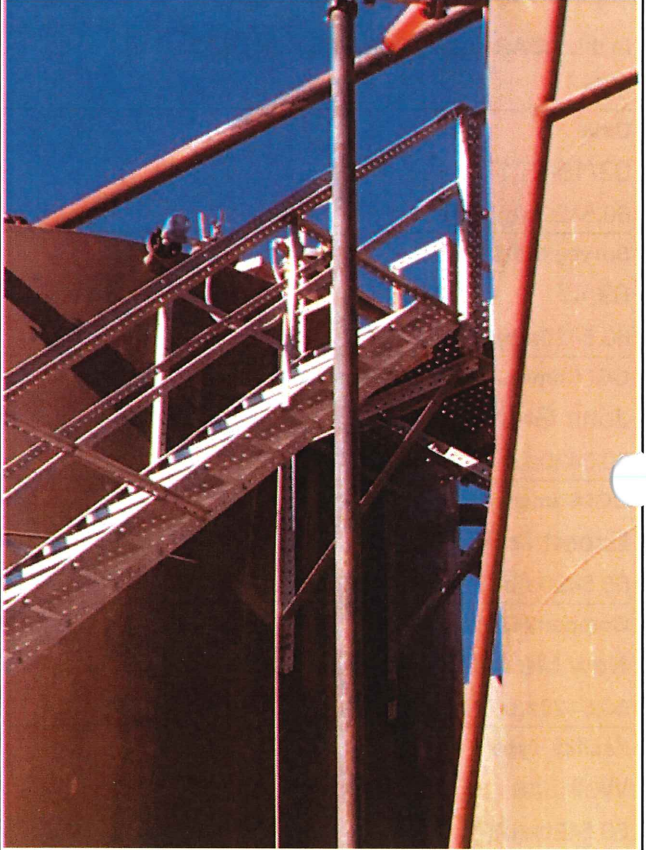
Type of Leaking Component?	Describe Leaking Component Location	Take iPhone photograph of leaking component and identify location.
Thief Hatch 60.5420a(b)(7)(vii) 60.5420a(b)(7)(viii)	Oil tank 3 thief hatch 60.5420a(c)(15)(ii)(l)(8)

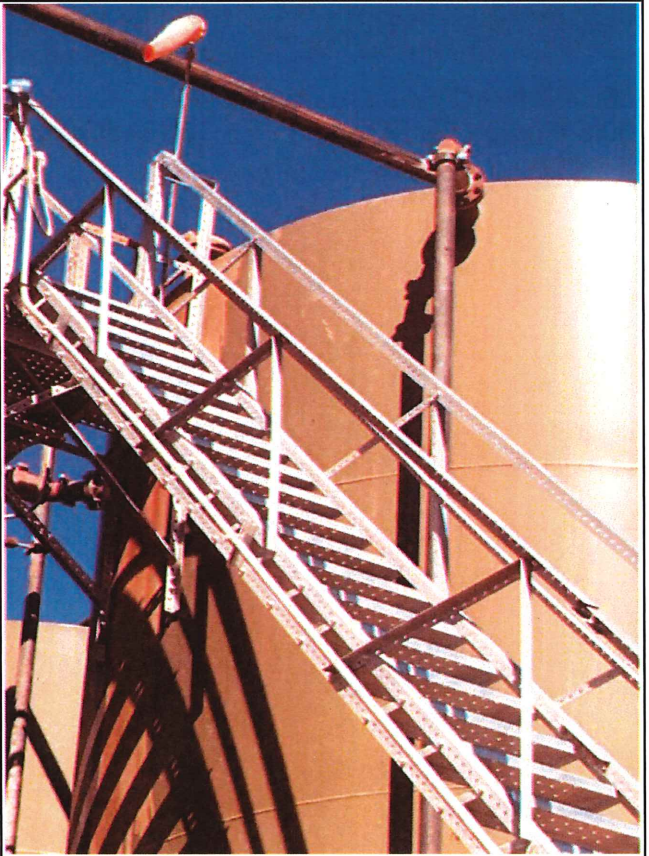
Type of Leaking Component?	Describe Leaking Component Location	Take iPhone photograph of leaking component and identify location.
Thief Hatch 60.5420a(b)(7)(vii) 60.5420a(b)(7)(viii)	Oil tank 6 60.5420a(c)(15)(ii)(l)(8)

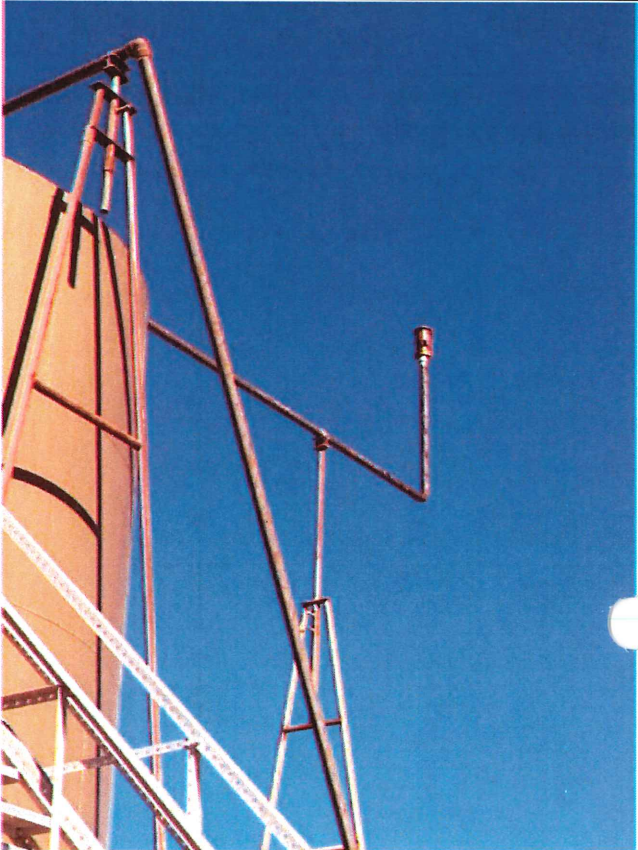
Type of Leaking Component?	Describe Leaking Component Location	Take iPhone photograph of leaking component and identify location.
Enardo Valve (PVRV) 60.5420a(b)(7)(vii) 60.5420a(b)(7)(viii)	Oil tank 6 common tank vent line enardo 60.5420a(c)(15)(ii)(l)(8)

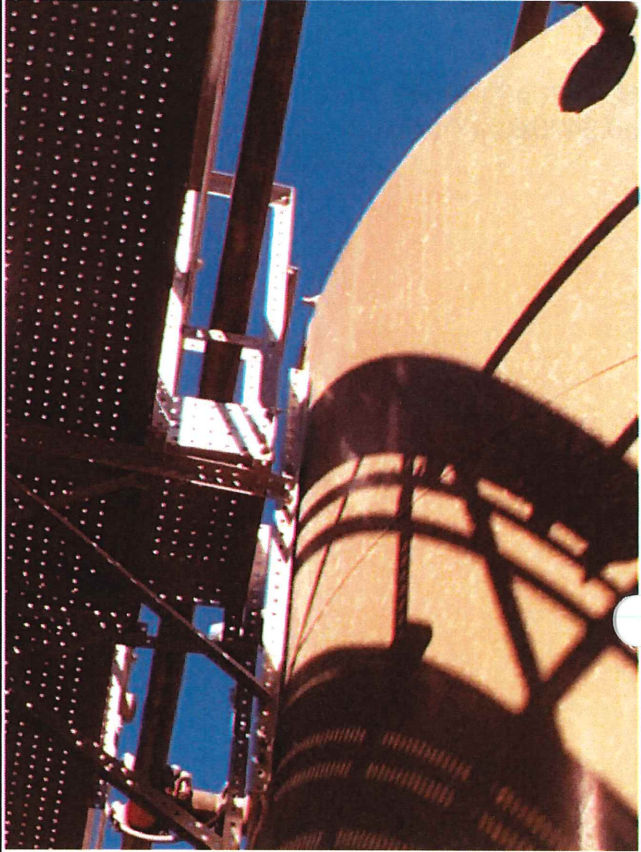
Type of Leaking Component?	Describe Leaking Component Location	Take iPhone photograph of leaking component and identify location.
Thief Hatch 60.5420a(b)(7)(vii) 60.5420a(b)(7)(viii)	Oil tank 5 thief hatch 60.5420a(c)(15)(ii)(I)(8)

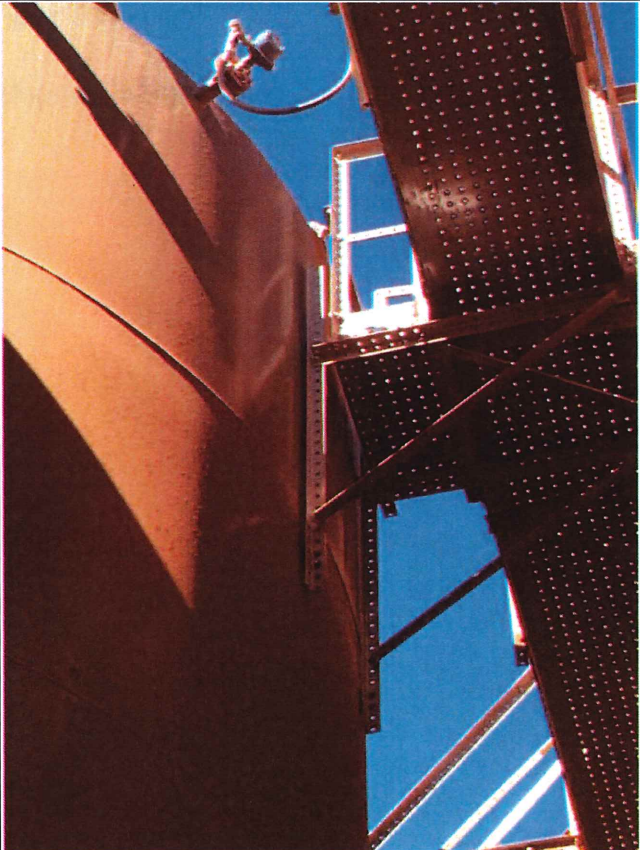
Type of Leaking Component?	Describe Leaking Component Location	Take iPhone photograph of leaking component and identify location.
Thief Hatch 60.5420a(b)(7)(vii) 60.5420a(b)(7)(viii)	Oil tank 1 thief hatch 60.5420a(c)(15)(ii)(l)(8)

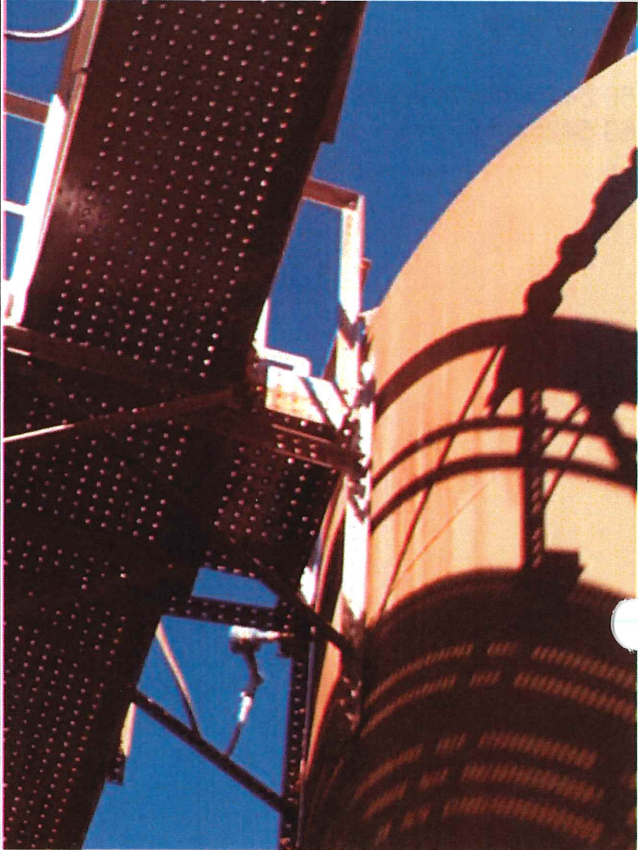
Type of Leaking Component?	Describe Leaking Component Location	Take iPhone photograph of leaking component and identify location.
Thief Hatch 60.5420a(b)(7)(vii) 60.5420a(b)(7)(viii)	Oil tank 4 thief hatch 60.5420a(c)(15)(ii)(I)(8)

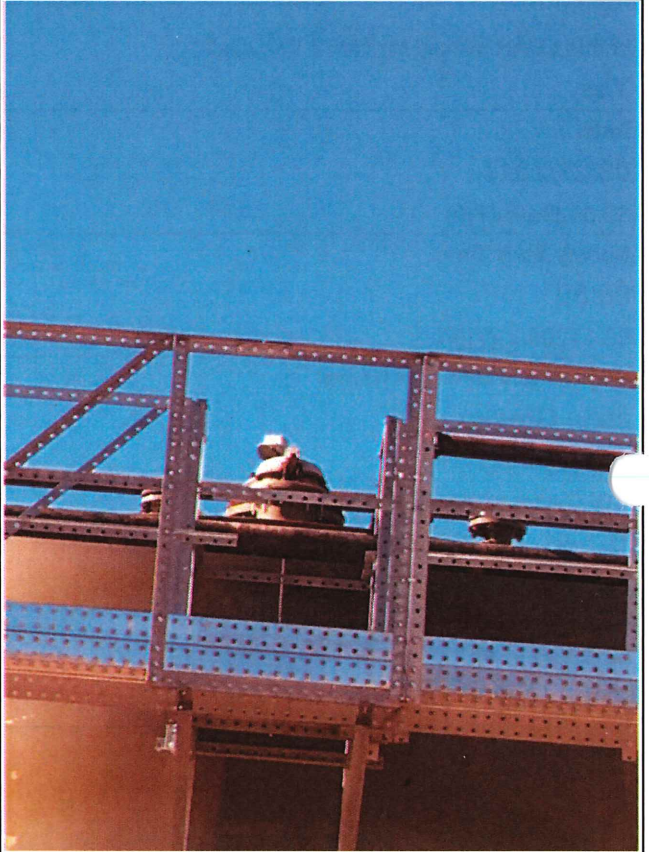
Type of Leaking Component?	Describe Leaking Component Location	Take iPhone photograph of leaking component and identify location.
Thief Hatch 60.5420a(b)(7)(vii) 60.5420a(b)(7)(viii)	Oil tank 2 thief hatch 60.5420a(c)(15)(ii)(l)(8)

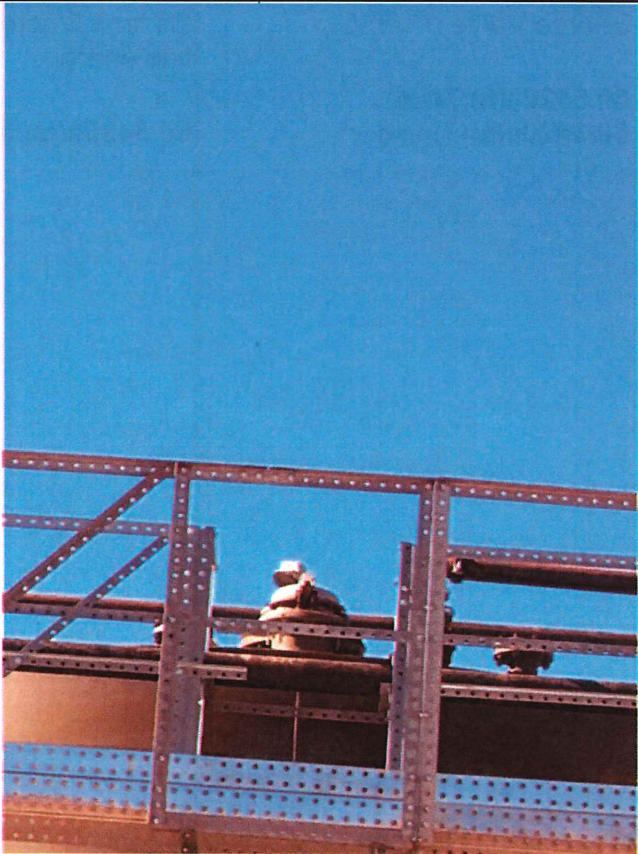
Type of Leaking Component?	Describe Leaking Component Location	Take iPhone photograph of leaking component and identify location.
Pressure Safety Valve (PSV) 60.5420a(b)(7)(vii) 60.5420a(b)(7)(viii)	Oil tank 2 tank safety relief valve 60.5420a(c)(15)(ii)(l)(8)

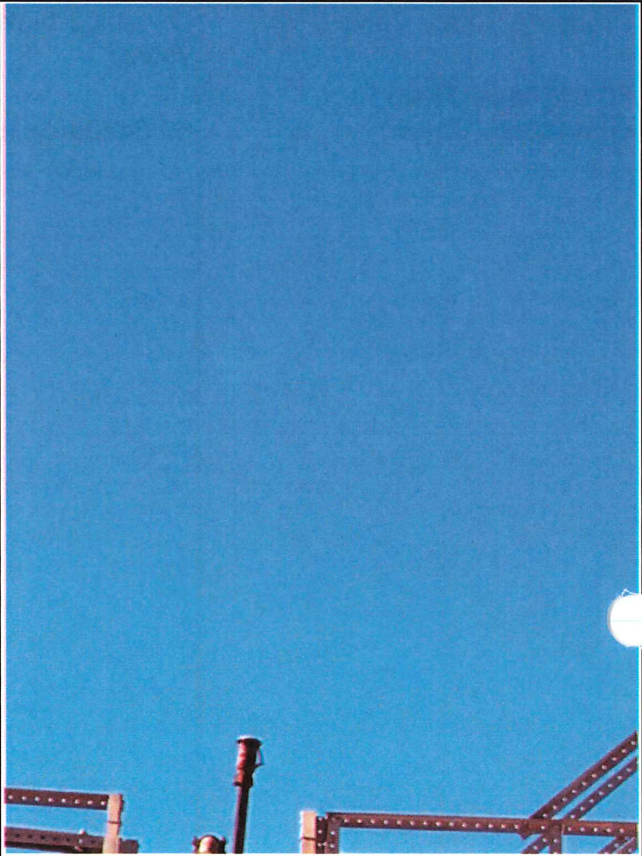
Type of Leaking Component?	Describe Leaking Component Location	Take iPhone photograph of leaking component and identify location.
Enardo Valve (PVRV) 60.5420a(b)(7)(vii) 60.5420a(b)(7)(viii)	Oil tank 3 common vent line enardo 60.5420a(c)(15)(ii)(l)(8)

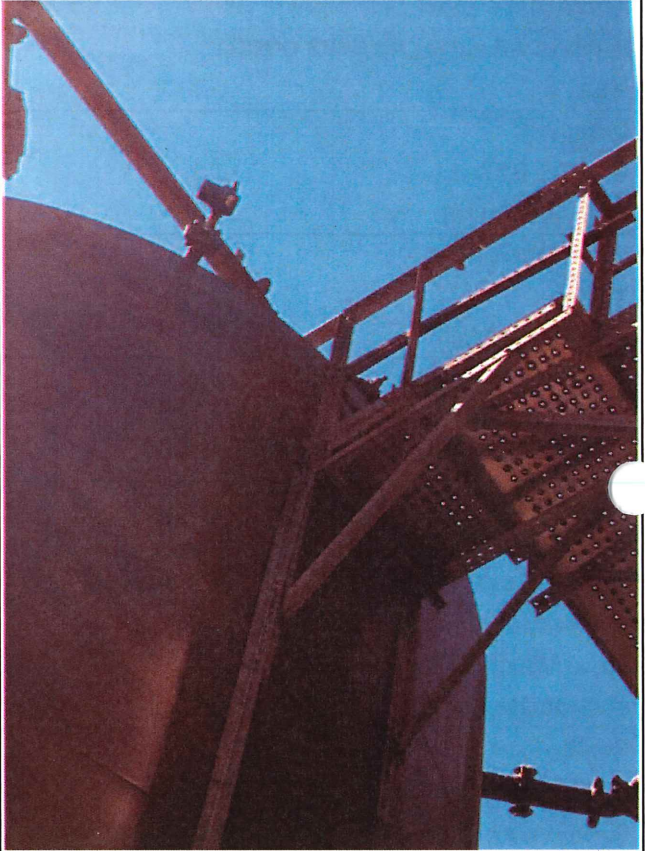
Type of Leaking Component?	Describe Leaking Component Location	Take iPhone photograph of leaking component and identify location.
Thief Hatch 60.5420a(b)(7)(vii) 60.5420a(b)(7)(viii)	Oil tank S/N 11305 south east thief hatch or tank relief 60.5420a(c)(15)(ii)(l)(8)

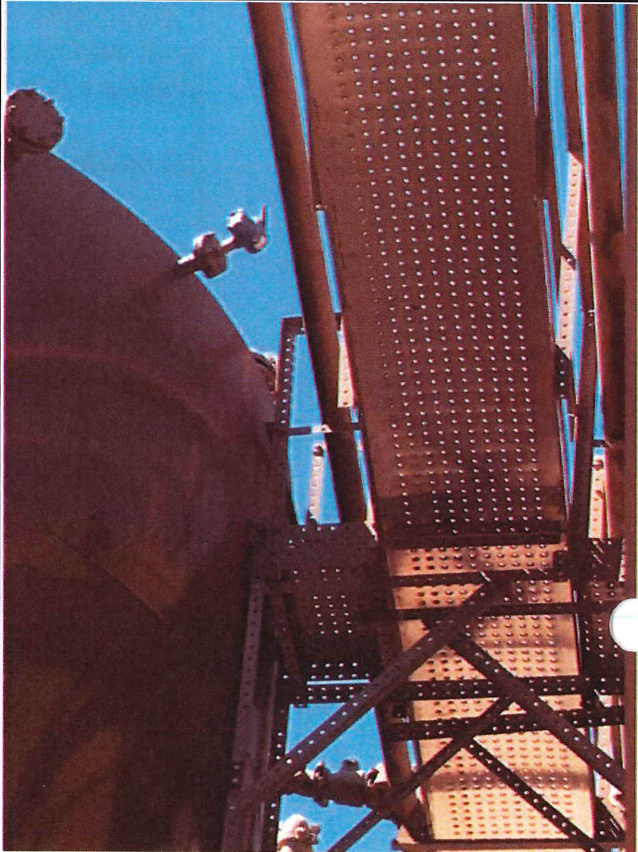
Type of Leaking Component?	Describe Leaking Component Location	Take iPhone photograph of leaking component and identify location.
Thief Hatch 60.5420a(b)(7)(vii) 60.5420a(b)(7)(viii)	Oil tank south middle thief hatch or tank pressure relief vent 60.5420a(c)(15)(ii)(I)(8)

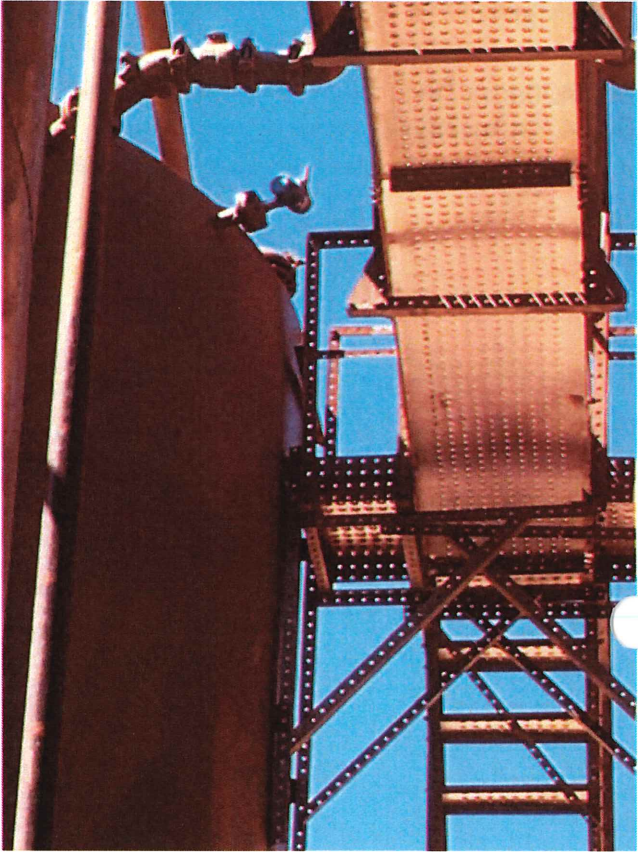
Type of Leaking Component?	Describe Leaking Component Location	Take iPhone photograph of leaking component and identify location.
Thief Hatch 60.5420a(b)(7)(vii) 60.5420a(b)(7)(viii)	Oil tank south west thief hatch or tank pressure relief vent 60.5420a(c)(15)(ii)(I)(8)

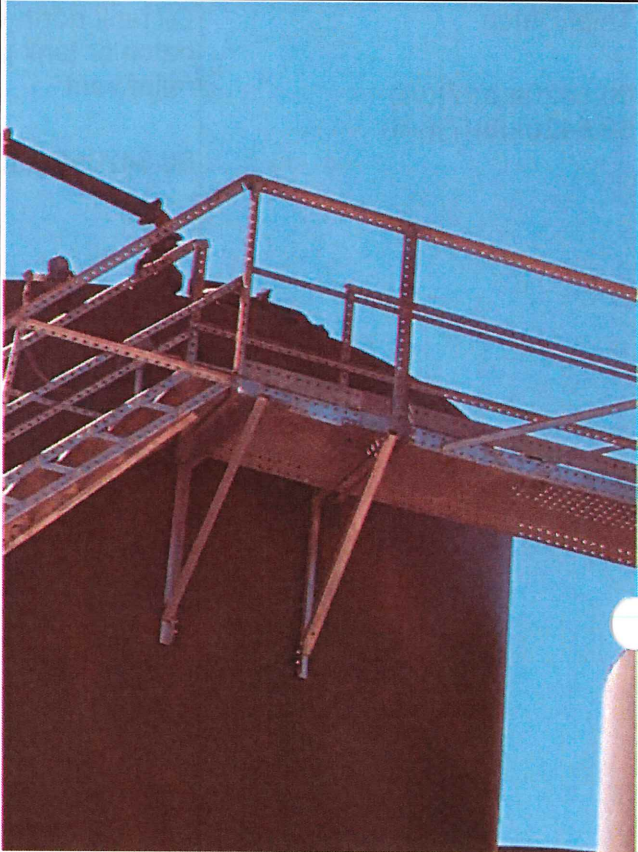
Type of Leaking Component?	Describe Leaking Component Location	Take iPhone photograph of leaking component and identify location.
Thief Hatch 60.5420a(b)(7)(vii) 60.5420a(b)(7)(viii)	West tank location oil tank S/N 27281 north east tank thief hatch or tank pressure relief vent 60.5420a(c)(15)(ii)(l)(8)

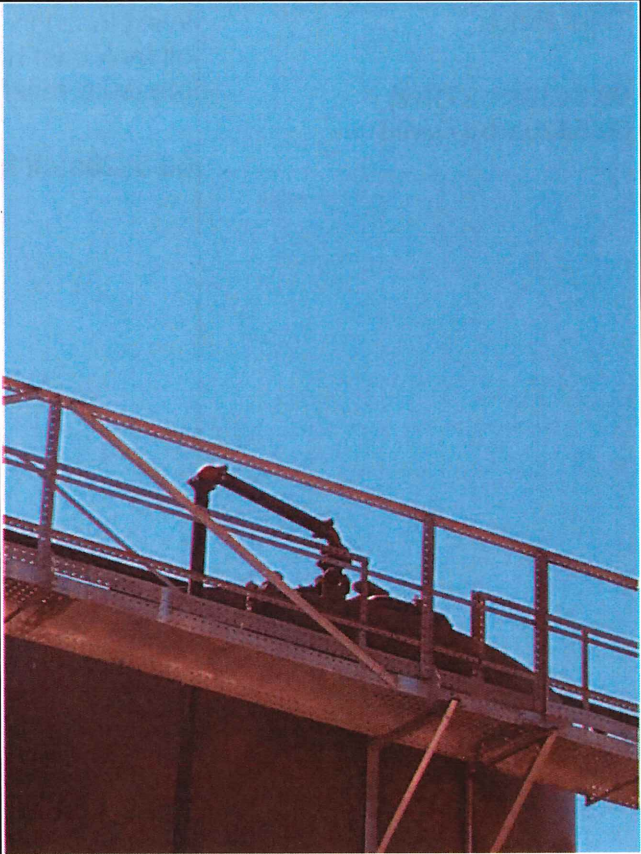
Type of Leaking Component?	Describe Leaking Component Location	Take iPhone photograph of leaking component and identify location.
Thief Hatch 60.5420a(b)(7)(vii) 60.5420a(b)(7)(viii)	West location middle oil tank thief hatch or tank pressure relief vent 60.5420a(c)(15)(ii)(I)(8)

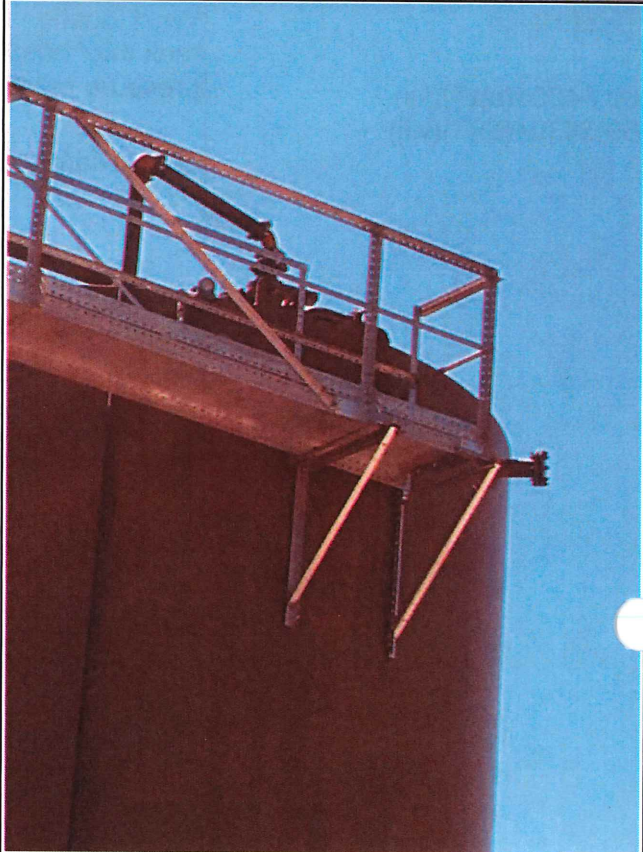
Type of Leaking Component?	Describe Leaking Component Location	Take iPhone photograph of leaking component and identify location.
Thief Hatch 60.5420a(b)(7)(vii) 60.5420a(b)(7)(viii)	West location north west oil tank thief hatch or tank pressure relief vent 60.5420a(c)(15)(ii)(l)(8)

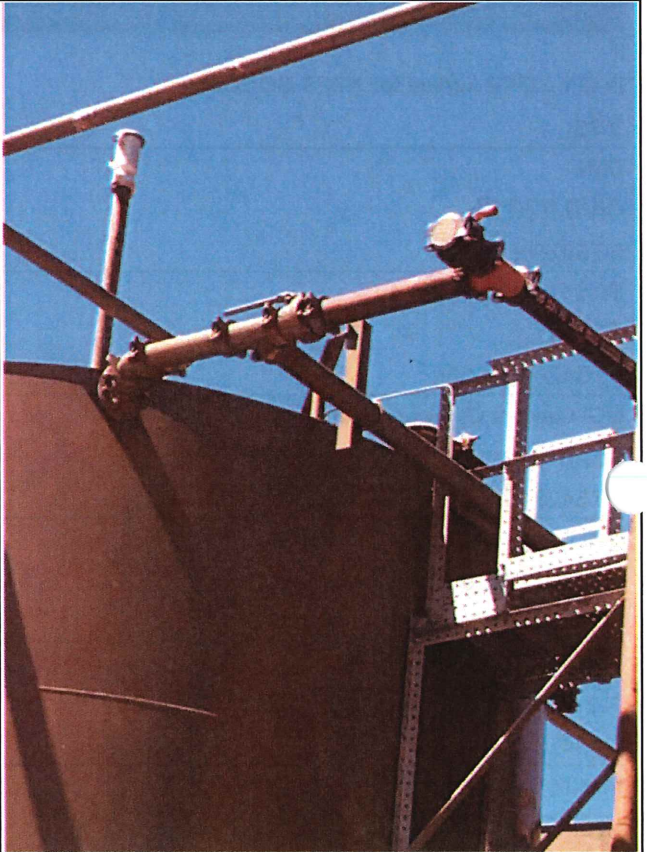
Type of Leaking Component?	Describe Leaking Component Location	Take iPhone photograph of leaking component and identify location.
Thief Hatch 60.5420a(b)(7)(vii) 60.5420a(b)(7)(viii)	Oil tank 1 thief hatch 60.5420a(c)(15)(ii)(l)(8)

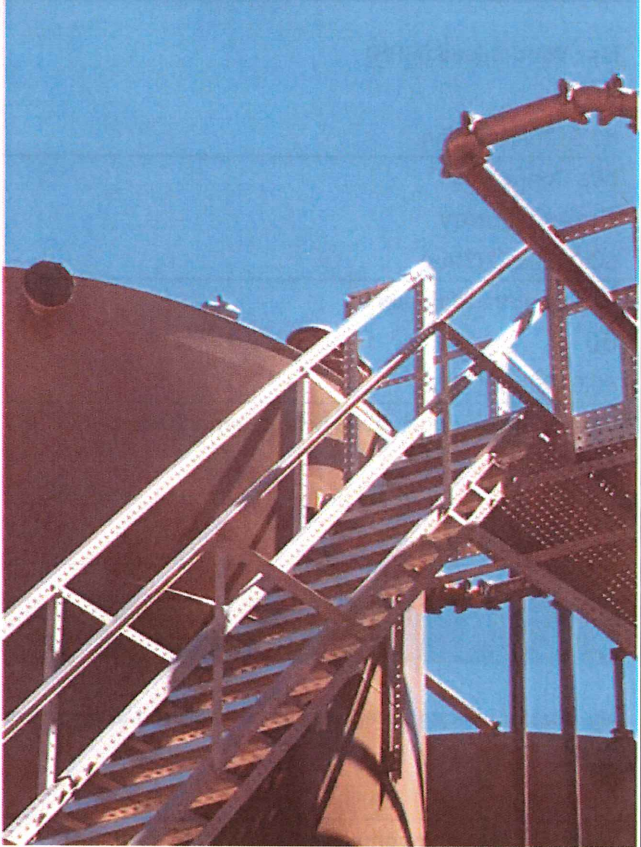
Type of Leaking Component?	Describe Leaking Component Location	Take iPhone photograph of leaking component and identify location.
Thief Hatch 60.5420a(b)(7)(vii) 60.5420a(b)(7)(viii)	Oil tank right behind oil tank 3 thief hatch 60.5420a(c)(15)(ii)(l)(8)

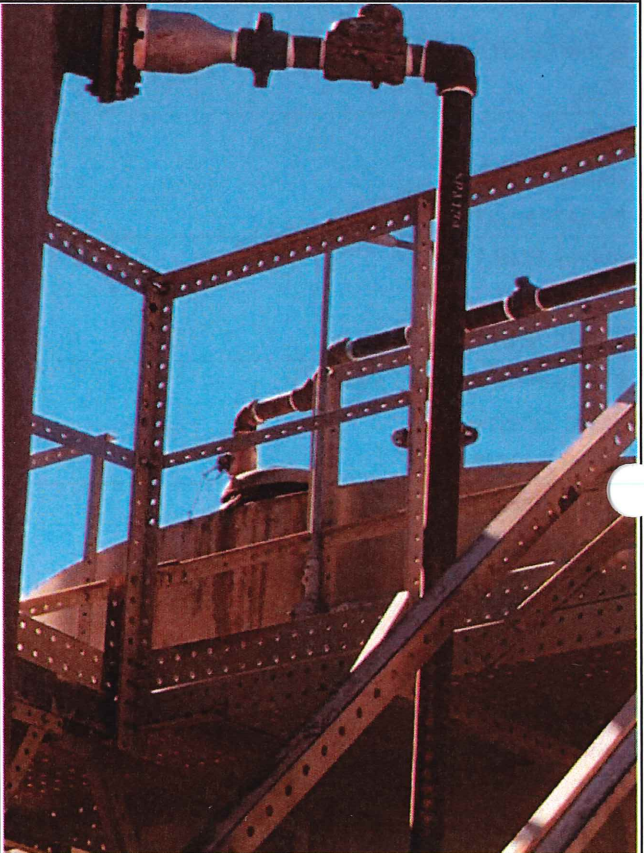
Type of Leaking Component?	Describe Leaking Component Location	Take iPhone photograph of leaking component and identify location.
Thief Hatch 60.5420a(b)(7)(vii) 60.5420a(b)(7)(viii)	Oil tank 1 (135432-1) east tank thief hatch. 60.5420a(c)(15)(ii)(l)(8)

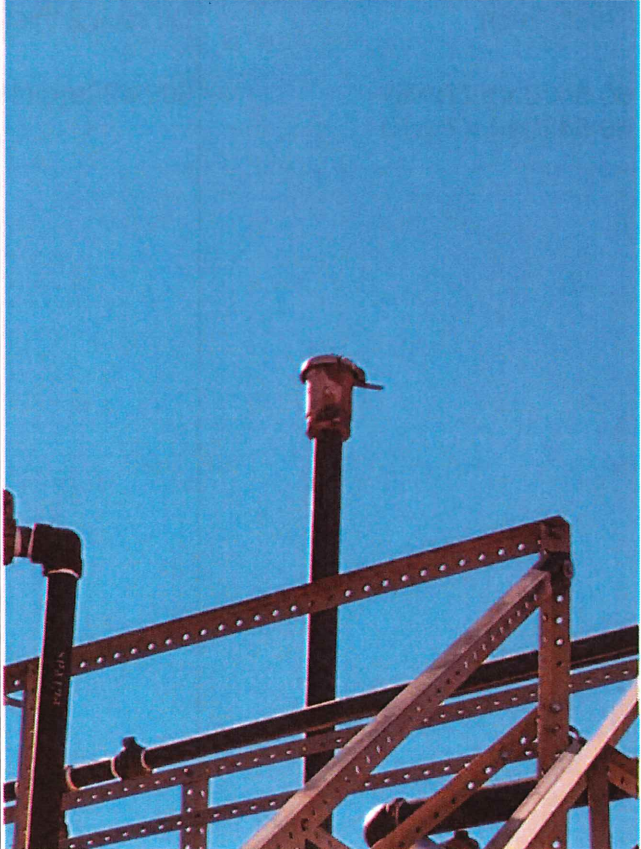
Type of Leaking Component?	Describe Leaking Component Location	Take iPhone photograph of leaking component and identify location.
Enardo Valve (PVRV) 60.5420a(b)(7)(vii) 60.5420a(b)(7)(viii)	Oil tank 1 common vent line enardo 60.5420a(c)(15)(ii)(l)(8)

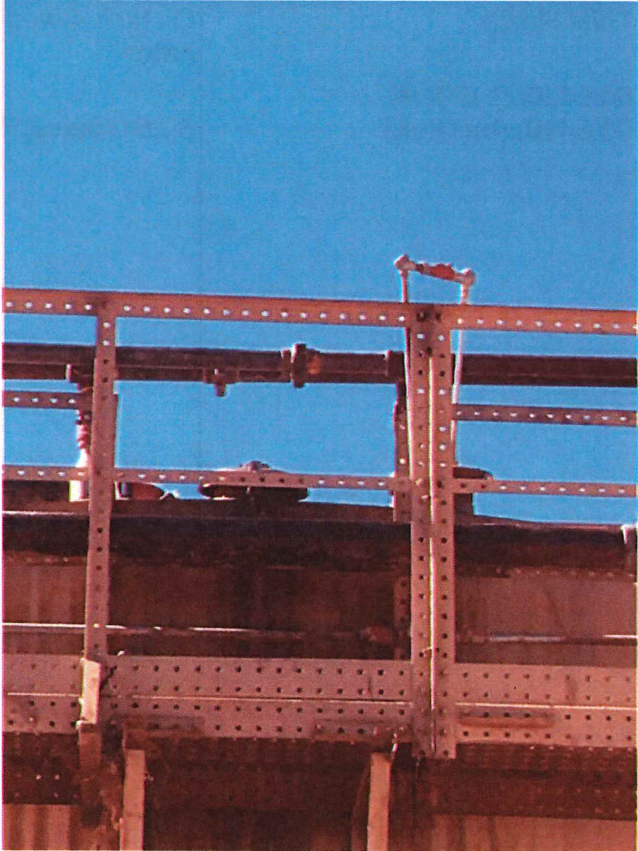
Type of Leaking Component?	Describe Leaking Component Location	Take iPhone photograph of leaking component and identify location.
Thief Hatch 60.5420a(b)(7)(vii) 60.5420a(b)(7)(viii)	Oil tank 3 thief hatch 60.5420a(c)(15)(ii)(I)(8)

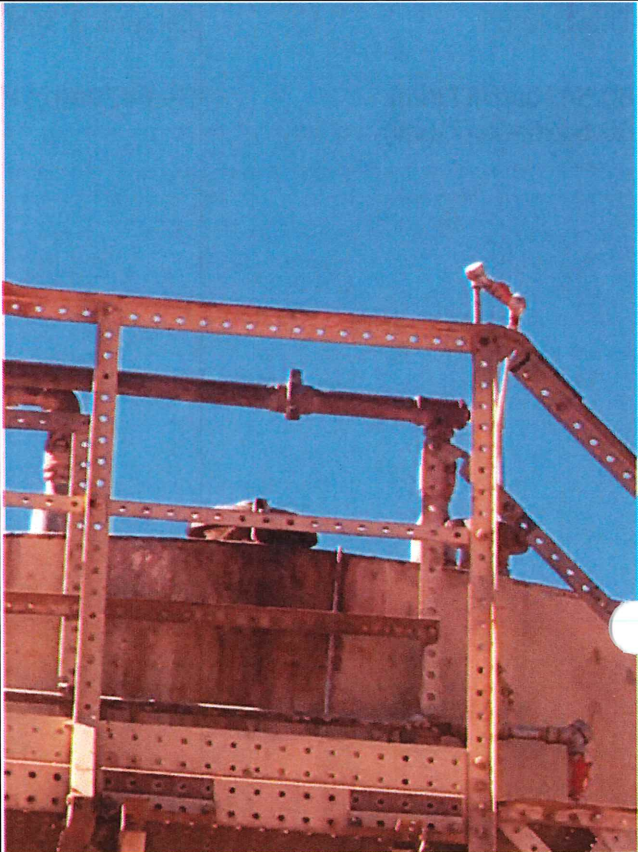
Type of Leaking Component?	Describe Leaking Component Location	Take iPhone photograph of leaking component and identify location.
Thief Hatch 60.5420a(b)(7)(vii) 60.5420a(b)(7)(viii)	Oil tank 4 west tank thief hatch 60.5420a(c)(15)(ii)(I)(8)

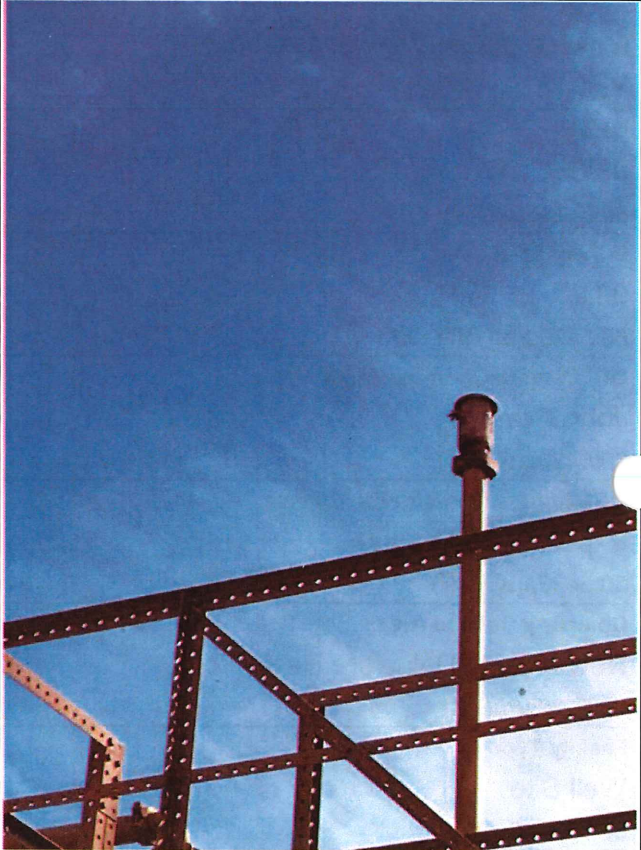
Type of Leaking Component?	Describe Leaking Component Location	Take iPhone photograph of leaking component and identify location.
Enardo Valve (PVRV) 60.5420a(b)(7)(vii) 60.5420a(b)(7)(viii)	PW tank enardo leaking 60.5420a(c)(15)(ii)(l)(8)

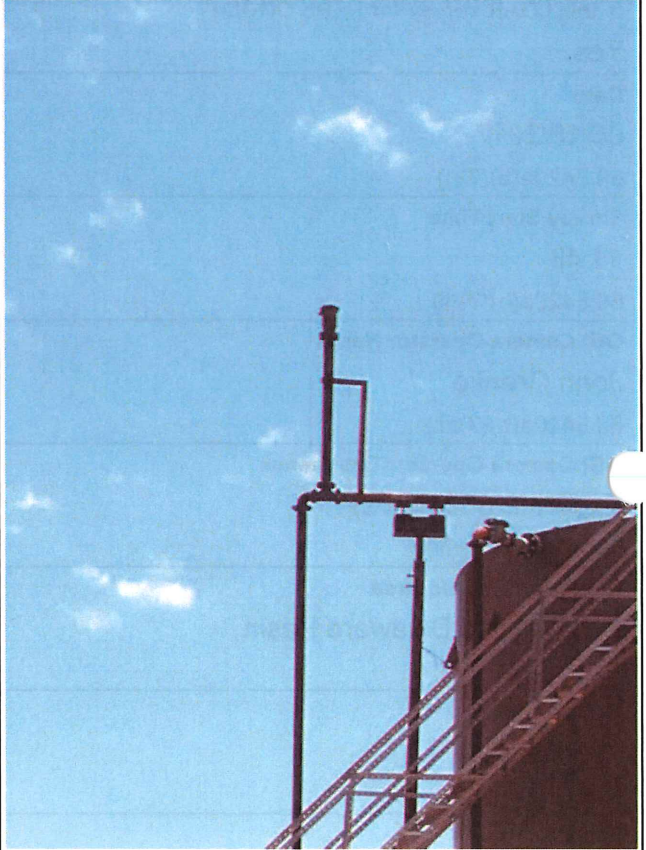
Type of Leaking Component?	Describe Leaking Component Location	Take iPhone photograph of leaking component and identify location.
Enardo Valve (PVRV) 60.5420a(b)(7)(vii) 60.5420a(b)(7)(viii)	Oil tank 1 common tank vent enardo 60.5420a(c)(15)(ii)(l)(8)

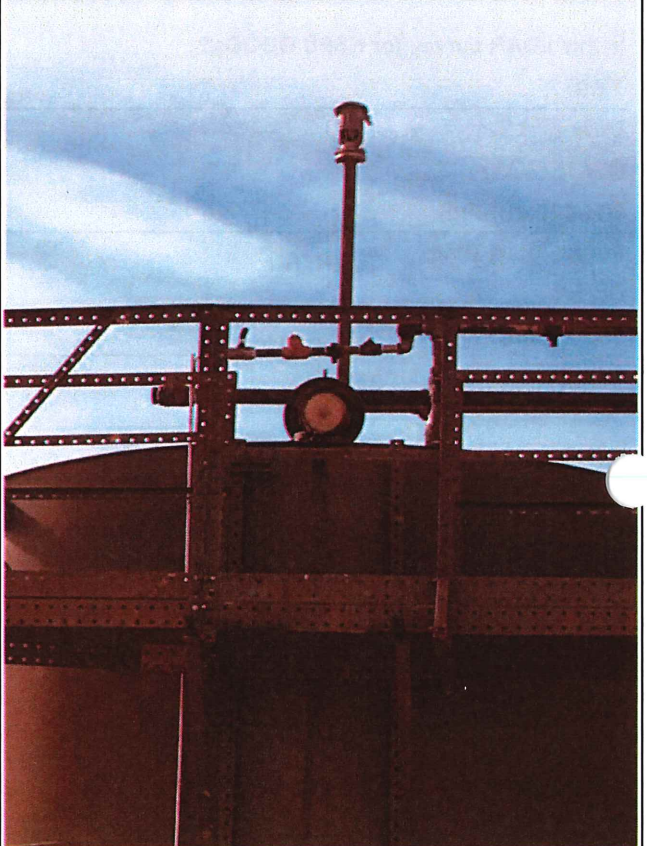
Type of Leaking Component?	Describe Leaking Component Location	Take iPhone photograph of leaking component and identify location.
Thief Hatch 60.5420a(b)(7)(vii) 60.5420a(b)(7)(viii)	Oil tank MI 302031 thief hatch open 60.5420a(c)(15)(ii)(l)(8)

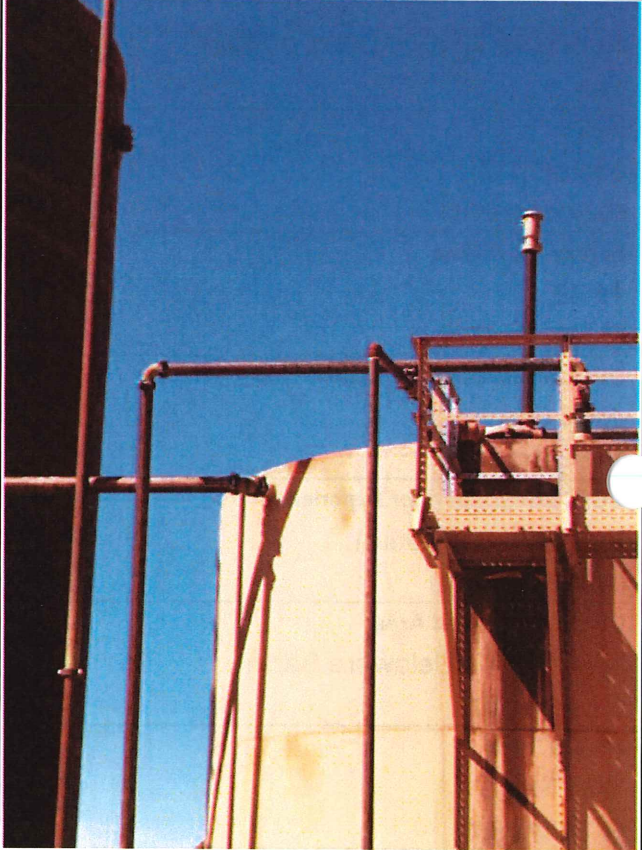
Type of Leaking Component?	Describe Leaking Component Location	Take iPhone photograph of leaking component and identify location.
Thief Hatch 60.5420a(b)(7)(vii) 60.5420a(b)(7)(viii)	Oil tank 1 next to PW tank thief hatch 60.5420a(c)(15)(ii)(I)(8)

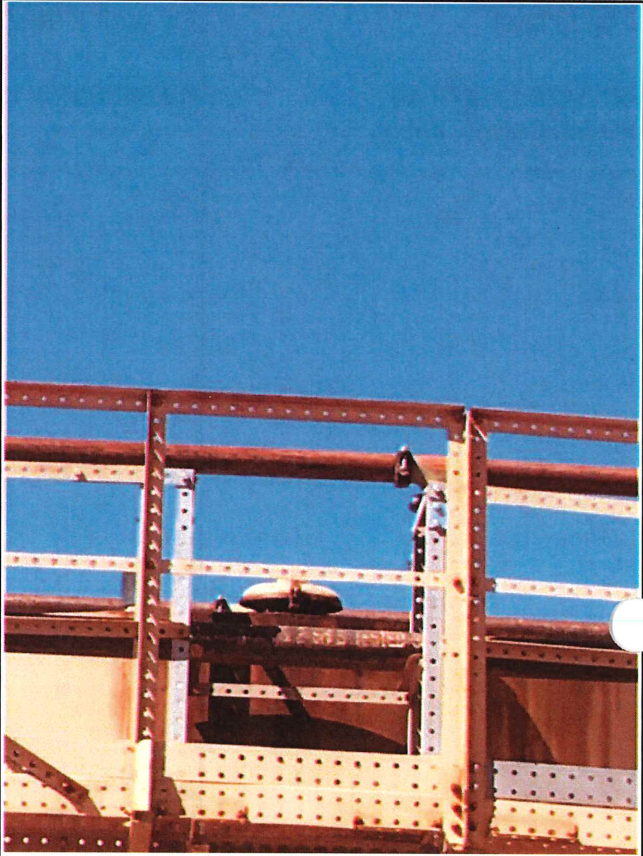
Type of Leaking Component?	Describe Leaking Component Location	Take iPhone photograph of leaking component and identify location.
Thief Hatch 60.5420a(b)(7)(vii) 60.5420a(b)(7)(viii)	Oil tank 3 thief hatch 60.5420a(c)(15)(ii)(l)(8)

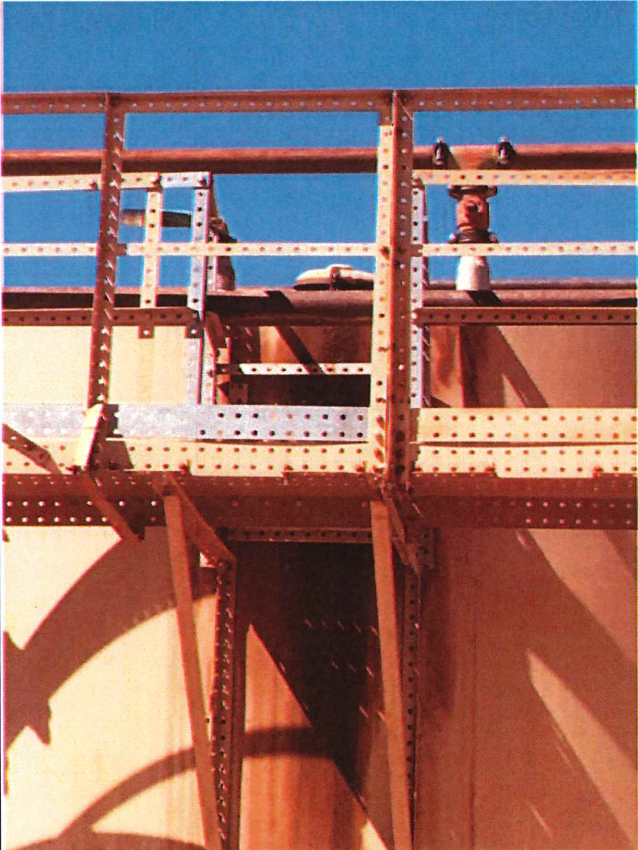
Type of Leaking Component?	Describe Leaking Component Location	Take iPhone photograph of leaking component and identify location.
Thief Hatch 60.5420a(b)(7)(vii) 60.5420a(b)(7)(viii)	Oil tank 4 thief hatch 60.5420a(c)(15)(ii)(l)(8)

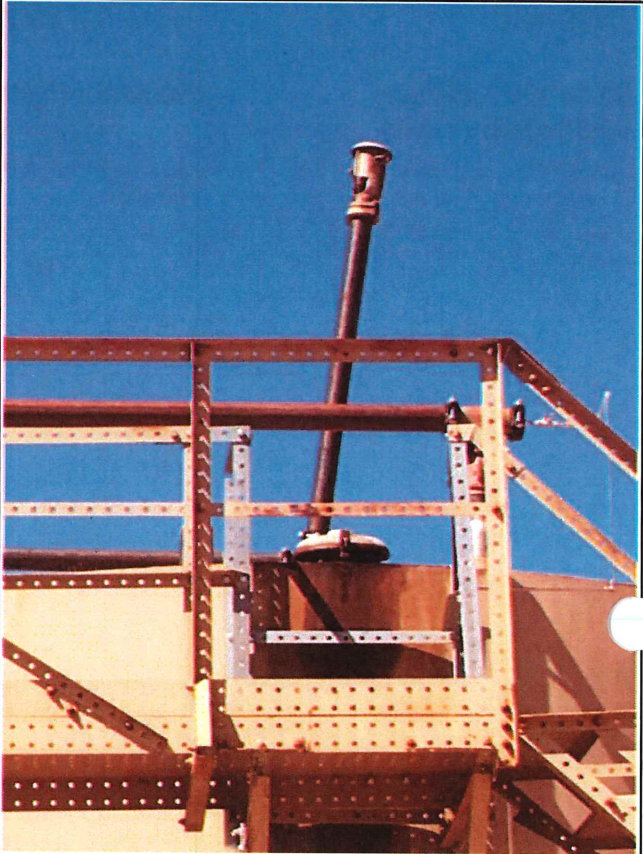
Type of Leaking Component?	Describe Leaking Component Location	Take iPhone photograph of leaking component and identify location.
Thief Hatch 60.5420a(b)(7)(vii) 60.5420a(b)(7)(viii)	Oil tank 5 thief hatch 60.5420a(c)(15)(ii)(l)(8)

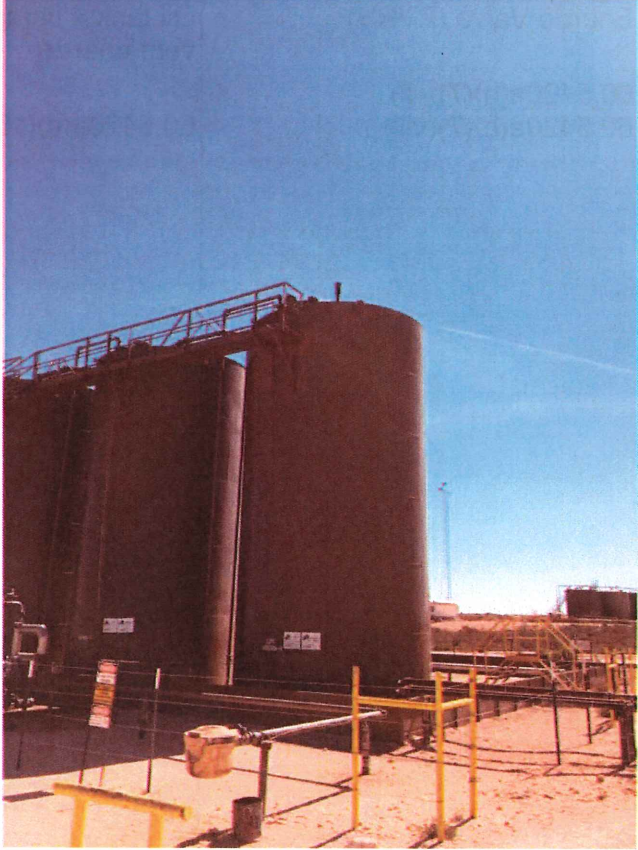
Type of Leaking Component?	Describe Leaking Component Location	Take iPhone photograph of leaking component and identify location.
Thief Hatch 60.5420a(b)(7)(vii) 60.5420a(b)(7)(viii)	Oil tank 4 thief hatch 60.5420a(c)(15)(ii)(I)(8)

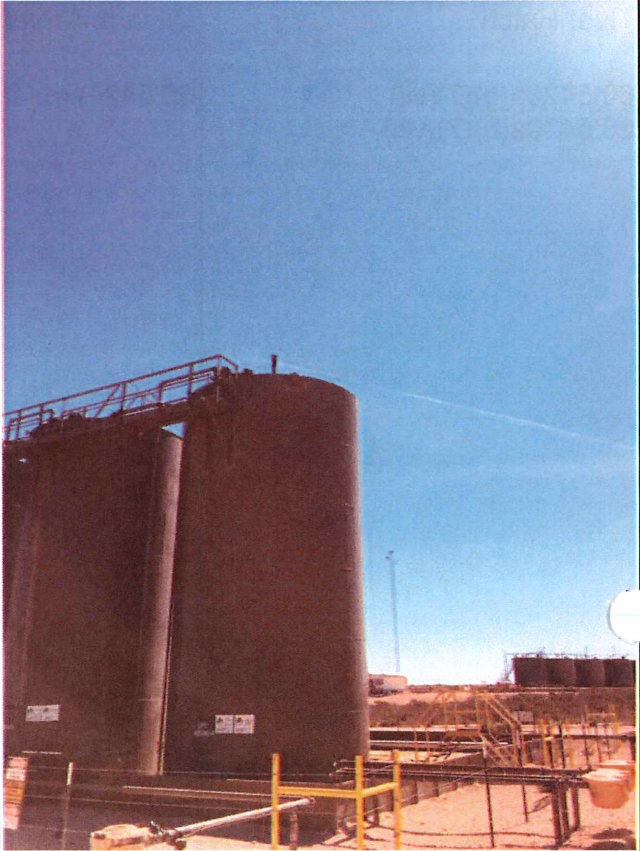
Type of Leaking Component?	Describe Leaking Component Location	Take iPhone photograph of leaking component and identify location.
Enardo Valve (PVRV) 60.5420a(b)(7)(vii) 60.5420a(b)(7)(viii)	Oil tank 4 common tank vent enardo 60.5420a(c)(15)(ii)(l)(8)
